Detection of delamination and impact damage in multilayered lightweight materials

Tobias Gautsch, Andreas Bodi, Manuel Lucas, Ralf Steinhausen, Mario Kiel

10th International Symposium on NDT in Aerospace, Dresden, October 25th, 2018

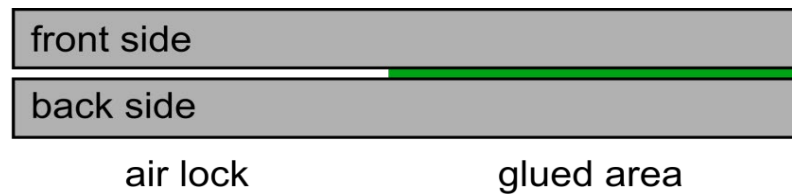
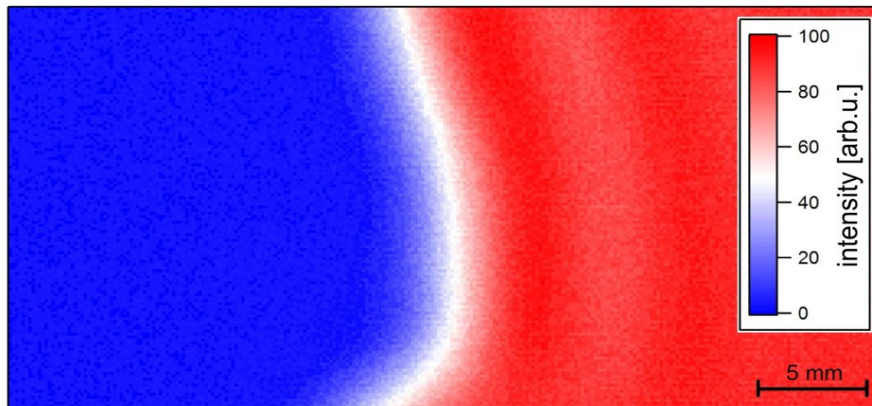
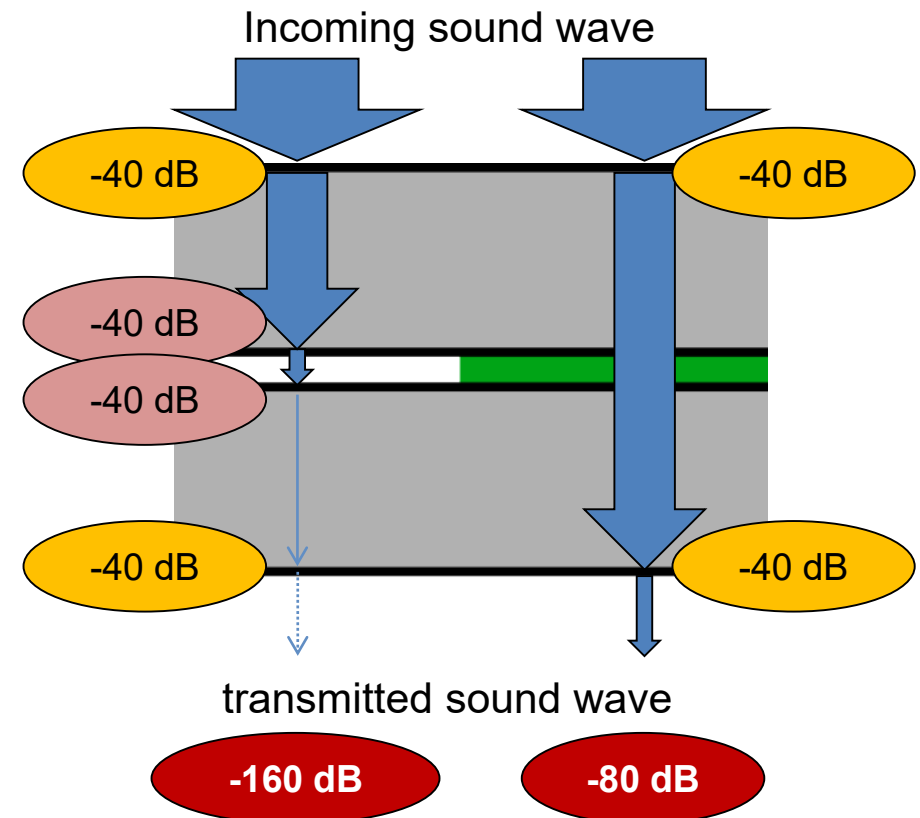
State of the art

- Missing adhesive leads to additional interfaces
- Intensity losses indicate vacancies

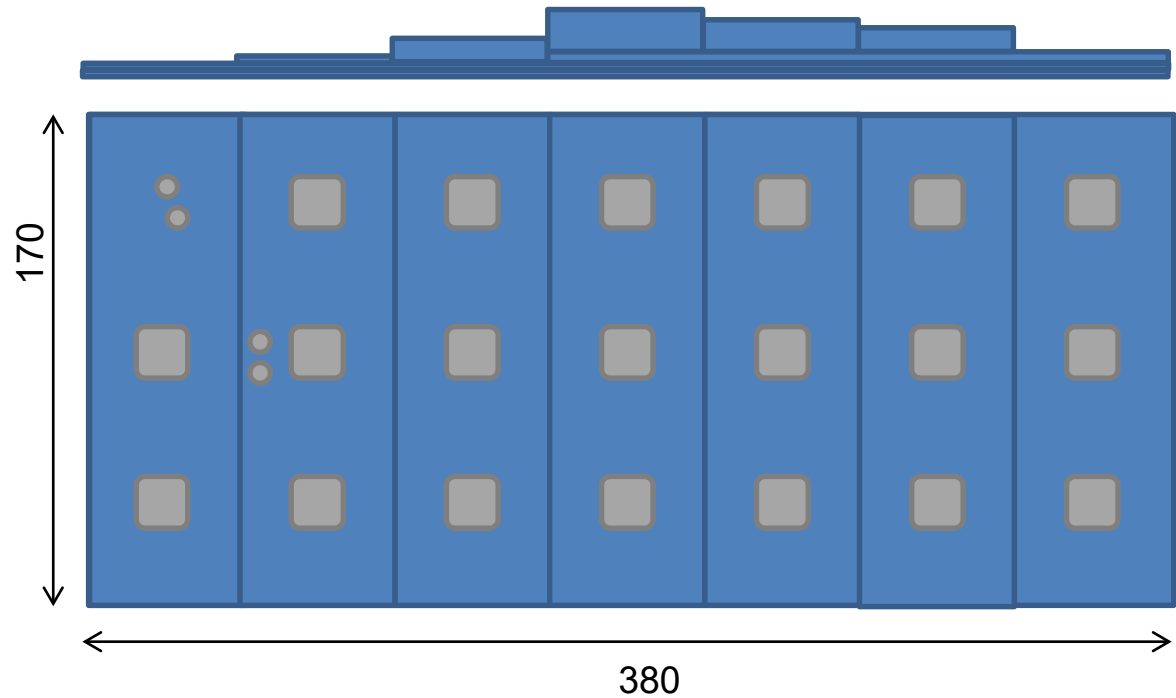
Specimen

- ▶ Aluminum Sheet Metal
 - ▶ Multiple Layers
 - ▶ 3.6 mm – 17.2 mm
- ▶ Adhesive Bonds
 - ▶ Artificial Delamination

Measurement Setup

- ▶ Trough Transmission
- ▶ Standoff Distance
 - ▶ 115 mm
 - ▶ Transmitter
 - ▶ 20 mm Receiver
- ▶ 600 mm / s

Step 1	Step 2	Step 3	Step 4	Step 5	Step 6	Step 7
1st Sheet				10.5 mm	8.7 mm	6.0 mm	
2nd Sheet		1.5 mm	5.7 mm	1.9 mm	1.9 mm	1.9 mm	1.9 mm
3rd Sheet	1.5 mm	1.5 mm	1.5 mm	1.5 mm	1.5 mm	1.5 mm	1.5 mm
4th Sheet	1.7 mm	1.7 mm	1.7 mm	1.7 mm	1.7 mm	1.7 mm	1.7 mm
Total	3.6 mm	5.2 mm	10.0 mm	17.2 mm	14.7 mm	12.5 mm	6.0 mm

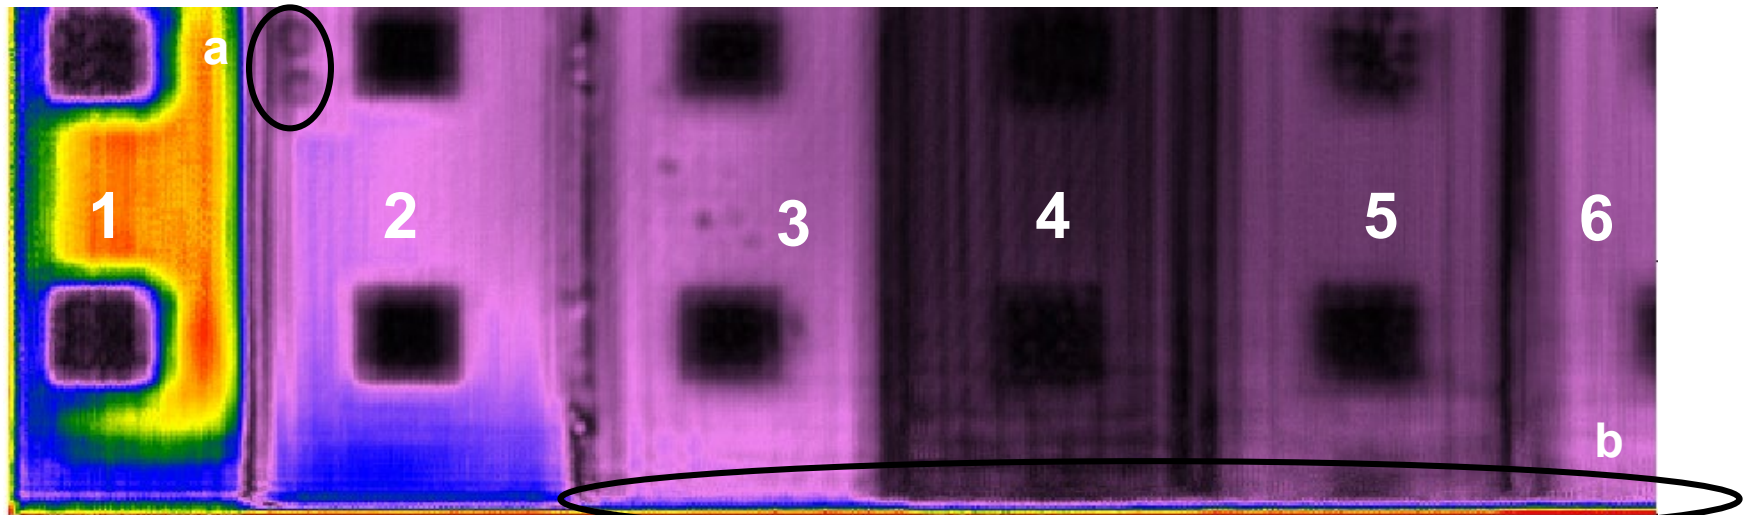
400 kHz - 25mm sender and receiver distance

- Very good spatial resolution
- ~12dB more amplitude in Segment 1 than in the others
- All discontinuities detectable including air bubbles in segment 3
- Round flaws (a) well separable
- Slight edge effects at the boundary of the object (b) and at the edges of each segment

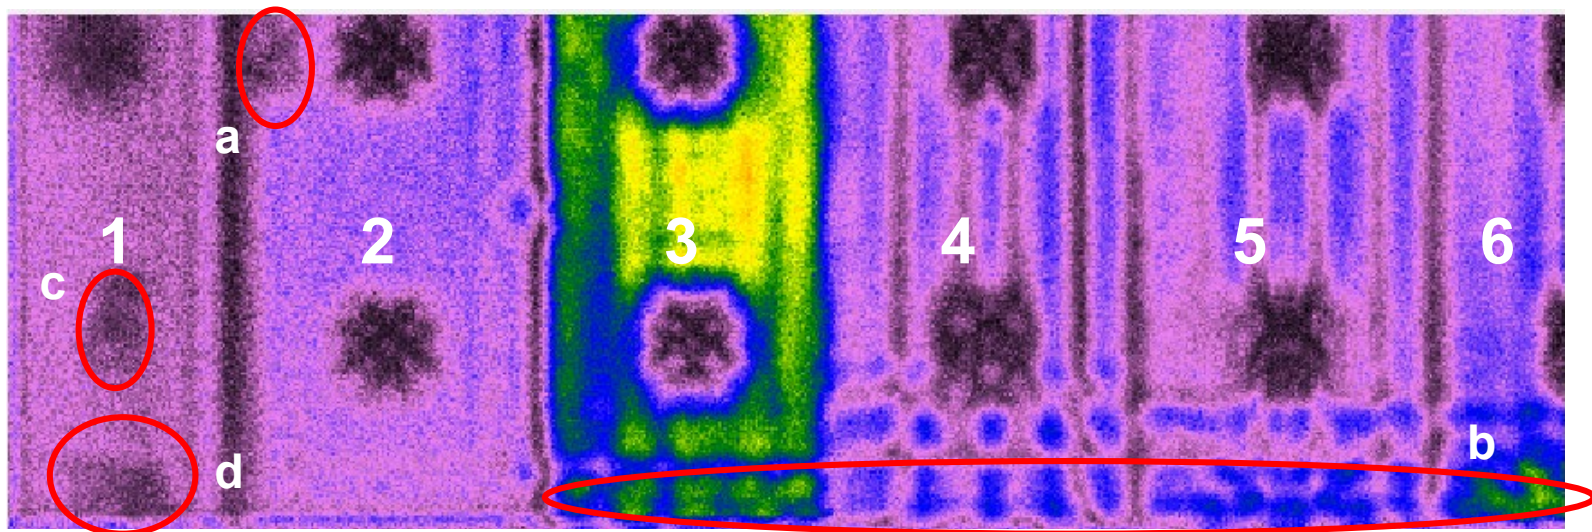
200 kHz - 114mm sender and 25 mm receiver distance

- Well testable with 200 kHz, improved detail due to 0,5 mm stepping
- All discontinuities detectable
- Round flaw (a) not separable
- Round flaws (c) at the surface and (d) at the backside detectable
- Significant edge effects at the boundary of the object (b) and at the edges of each segment
- Segment 3 significantly more permeable than the other segments

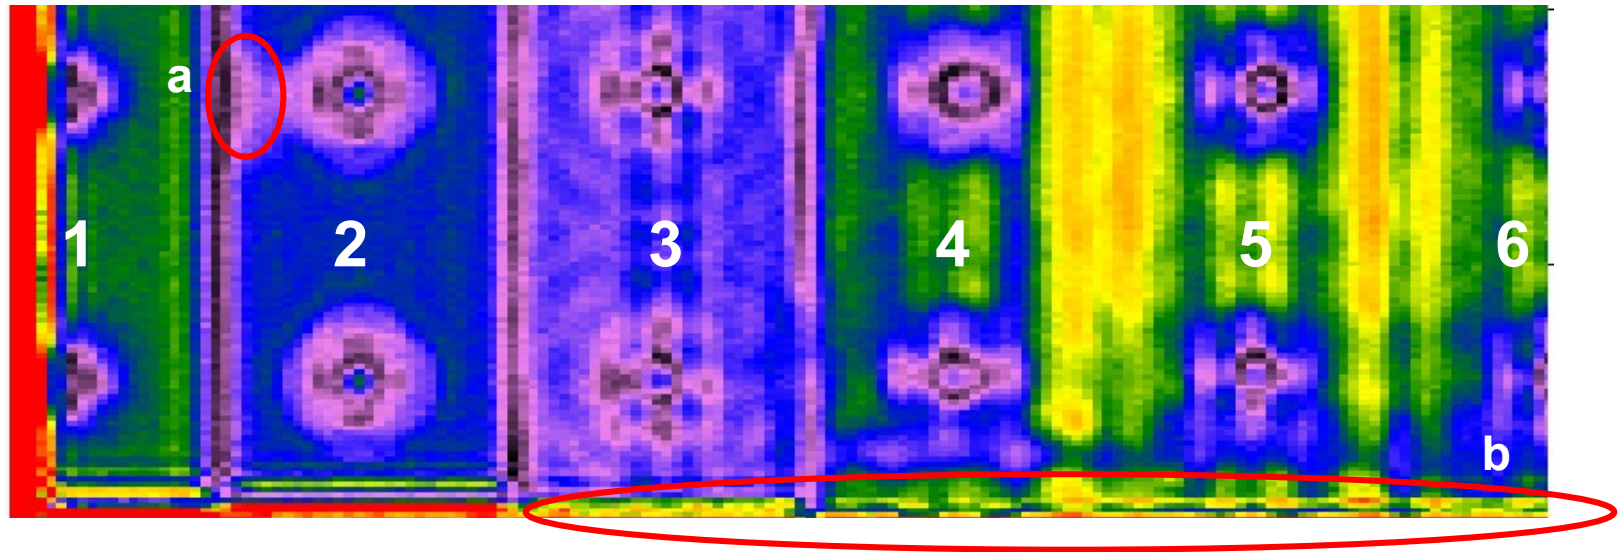
125 kHz - 114mm sender and 25 mm receiver distance

- ▶ Better SNR with 125 kHz than with 200 kHz
- ▶ Less spatial resolution than with 200 kHz
- ▶ All discontinuities detectable, but the resolution is too low to represent the squares correctly
- ▶ Round flaws (a) not separable
- ▶ Significant edge effects at the boundary of the object (b) and at the edges of each segment

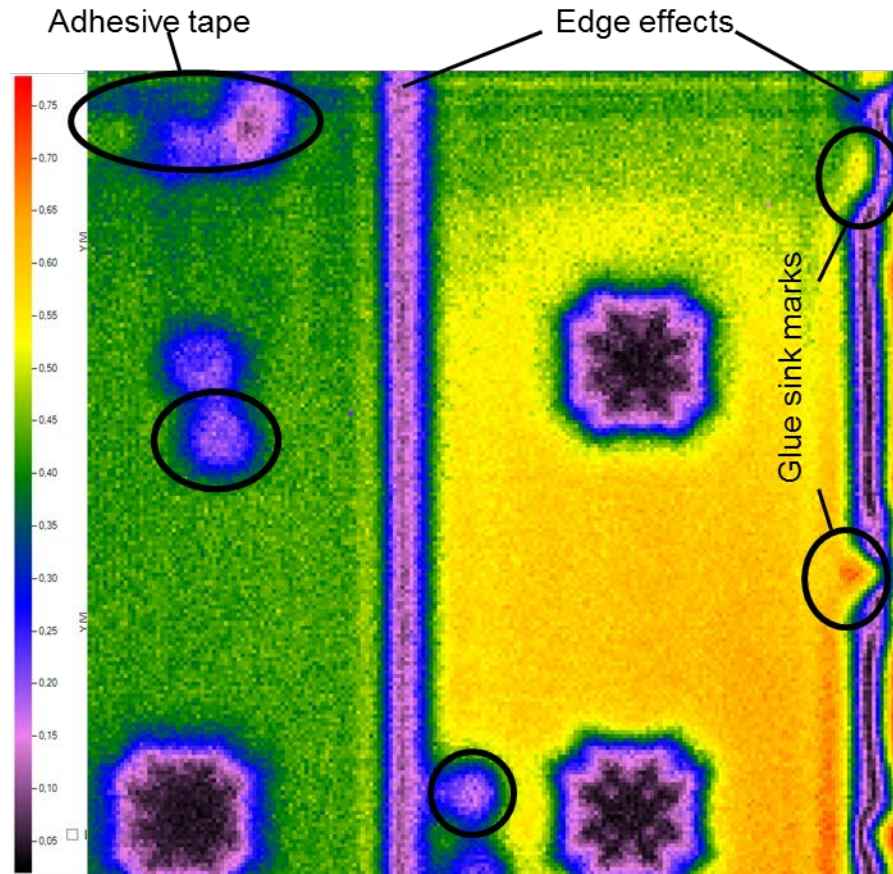
Linear Scale

200 kHz - 10 mm sender and receiver distance

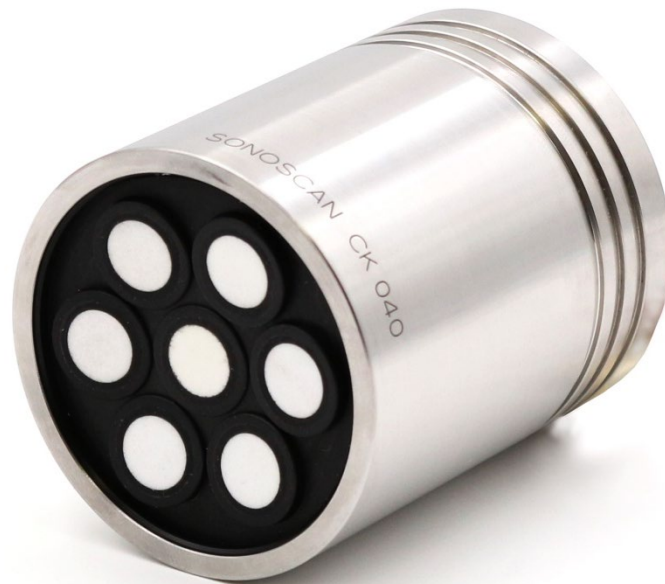
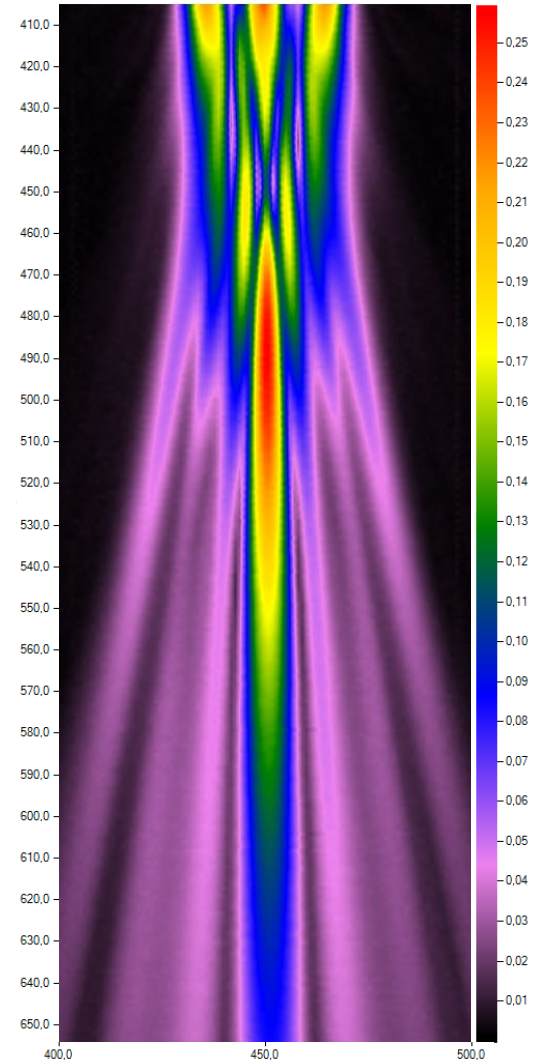
Transducer Development

- Multi-Element Transducer
- Seven Elements
- 45 mm Aperture
- 115 mm Focal Distance

- ▶ The Measurement Task can be fulfilled with the SONOAIR System
- ▶ Frequency dependent changes in Trough Transmission Measurement could be found
- ▶ A custom Transducer with 115 mm focal distance and 200 kHz mean frequency was developed
- ▶ 6dB minimum SNR were achieved at 333 Hz PFR and 115 mm standoff distance

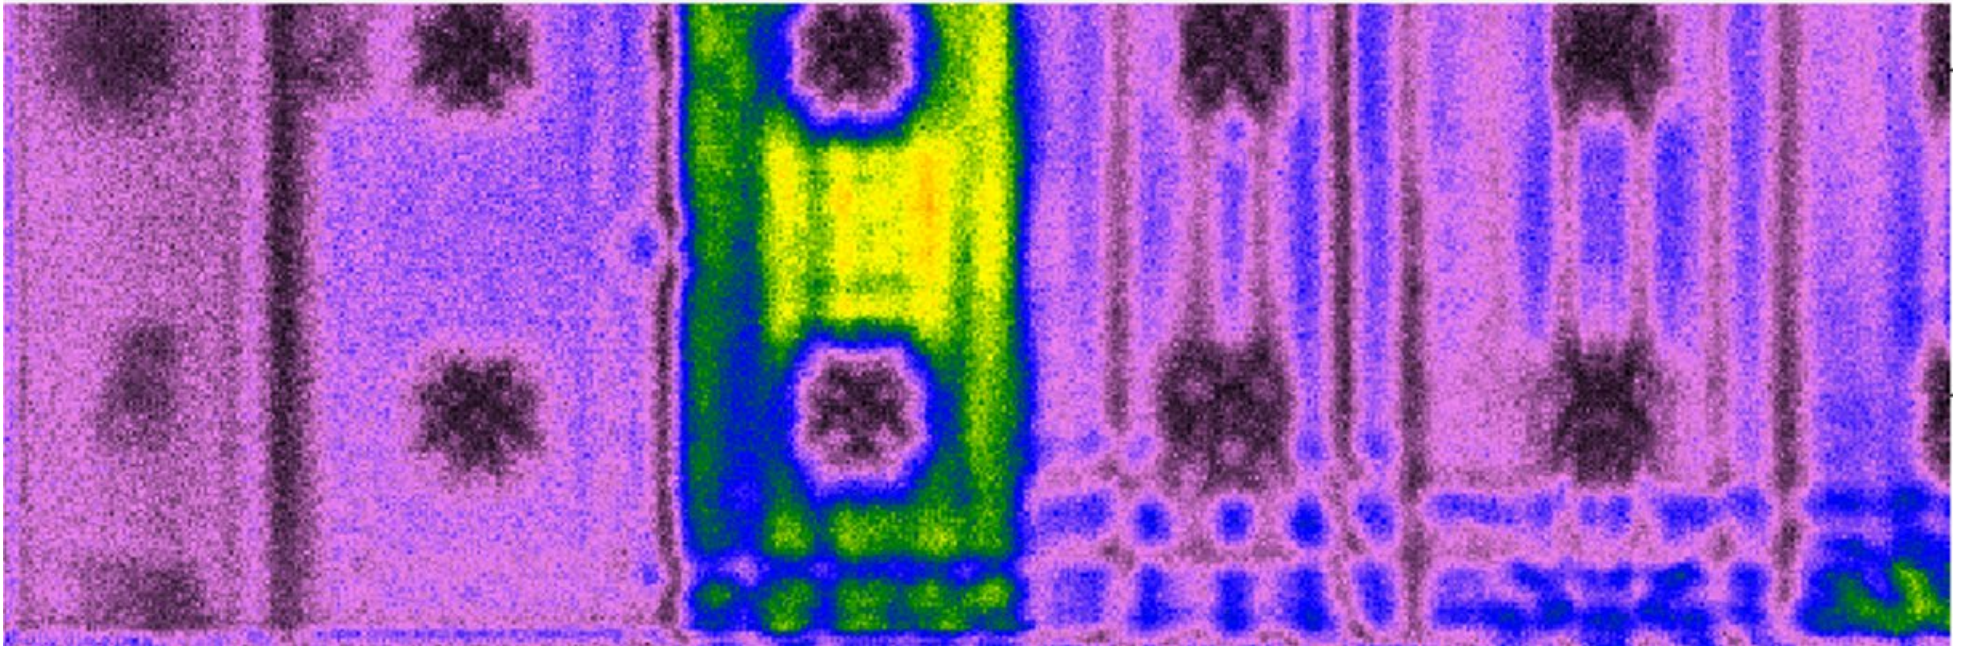
Standard 200 kHz Measurement

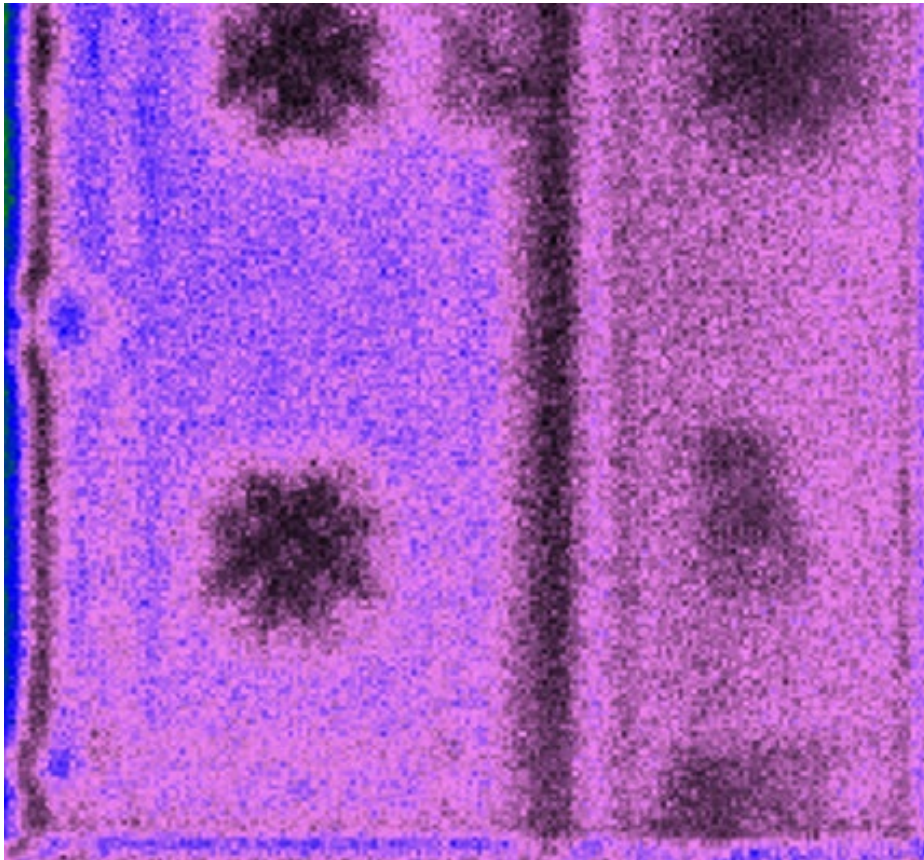
Standard CF200 Transducer

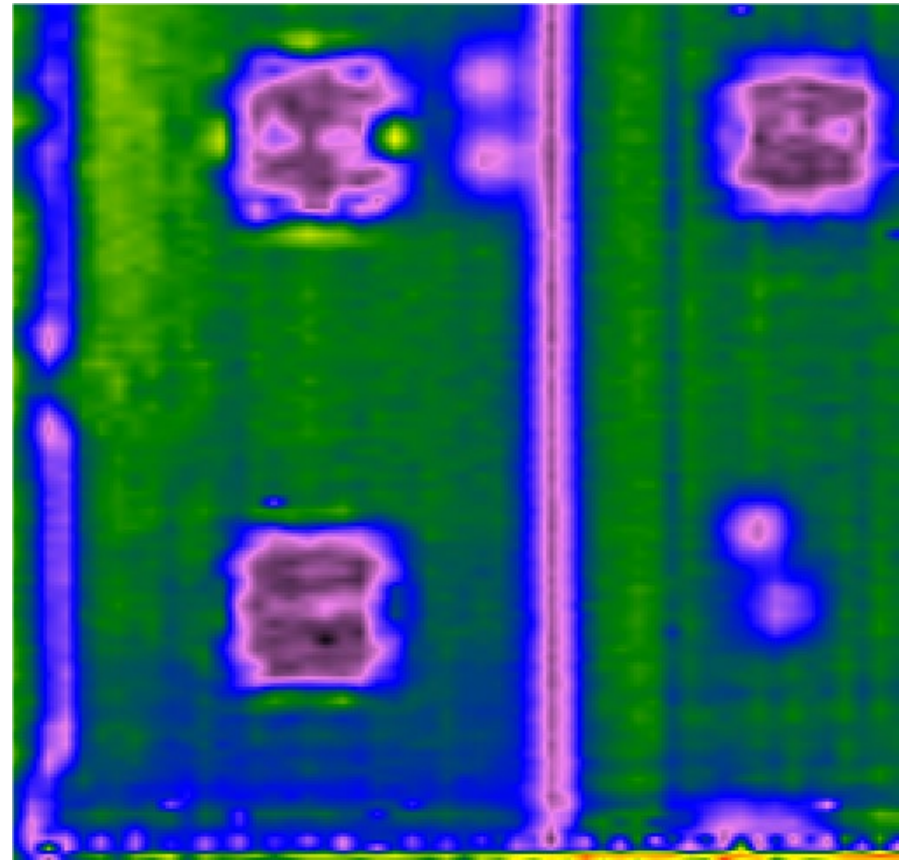
Custom CF200 7E Transducer with 115 mm Focal distance

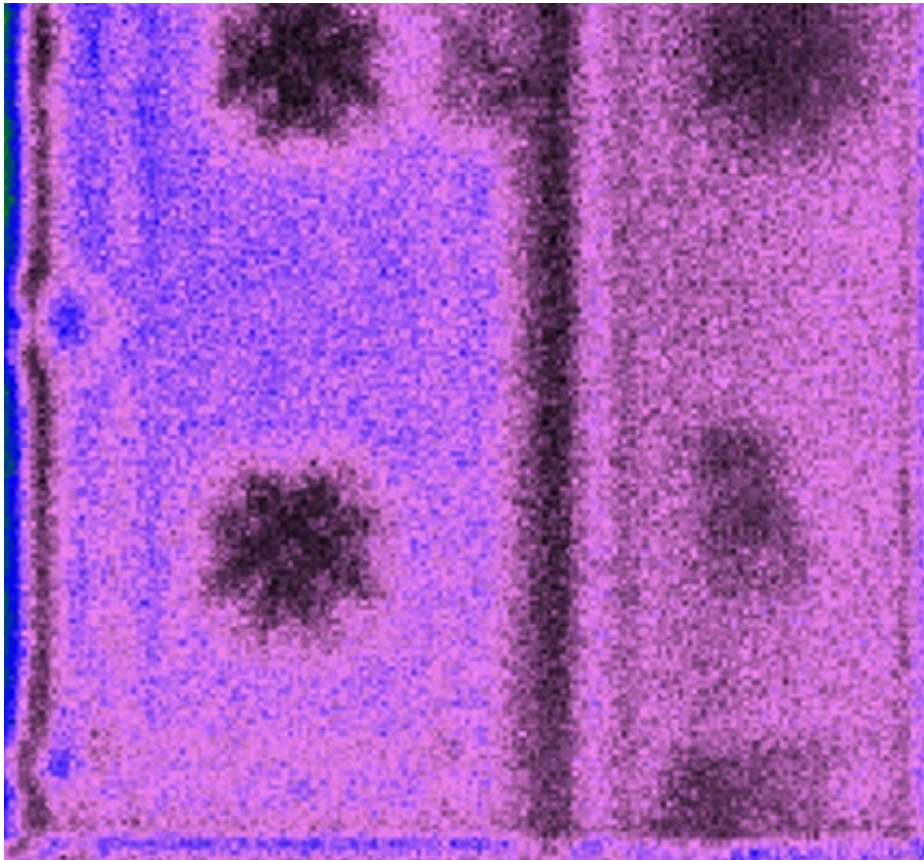
Standard CF200 Transducer

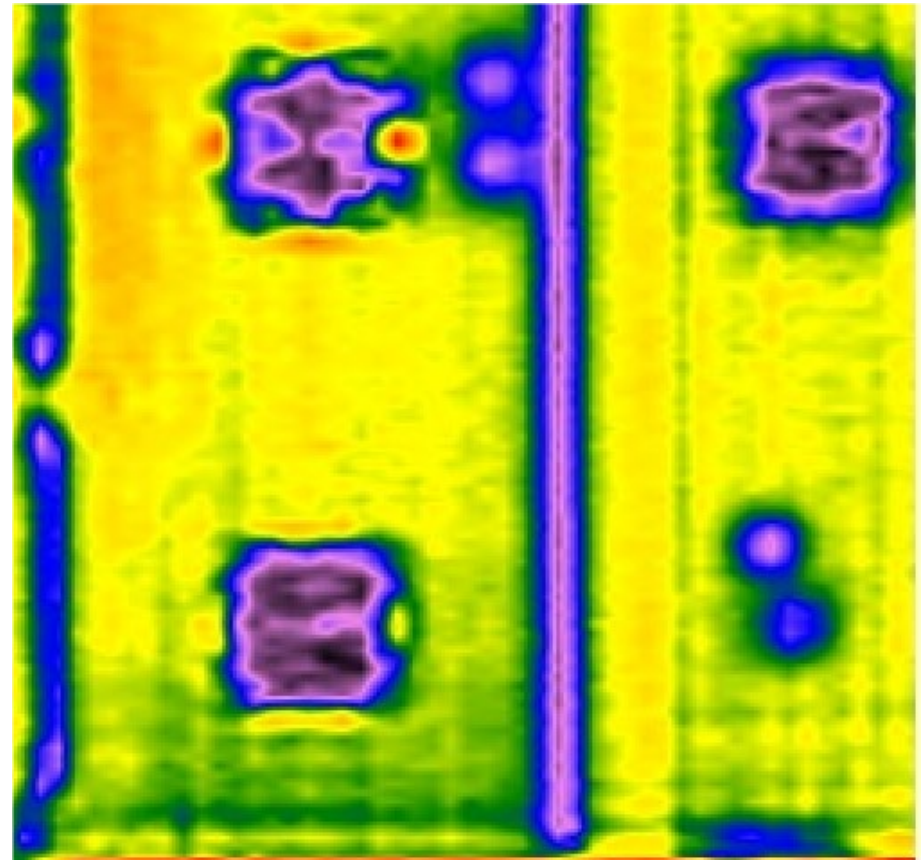
Custom CF200 7E Transducer with 115 mm Focal distance in dB-Scale

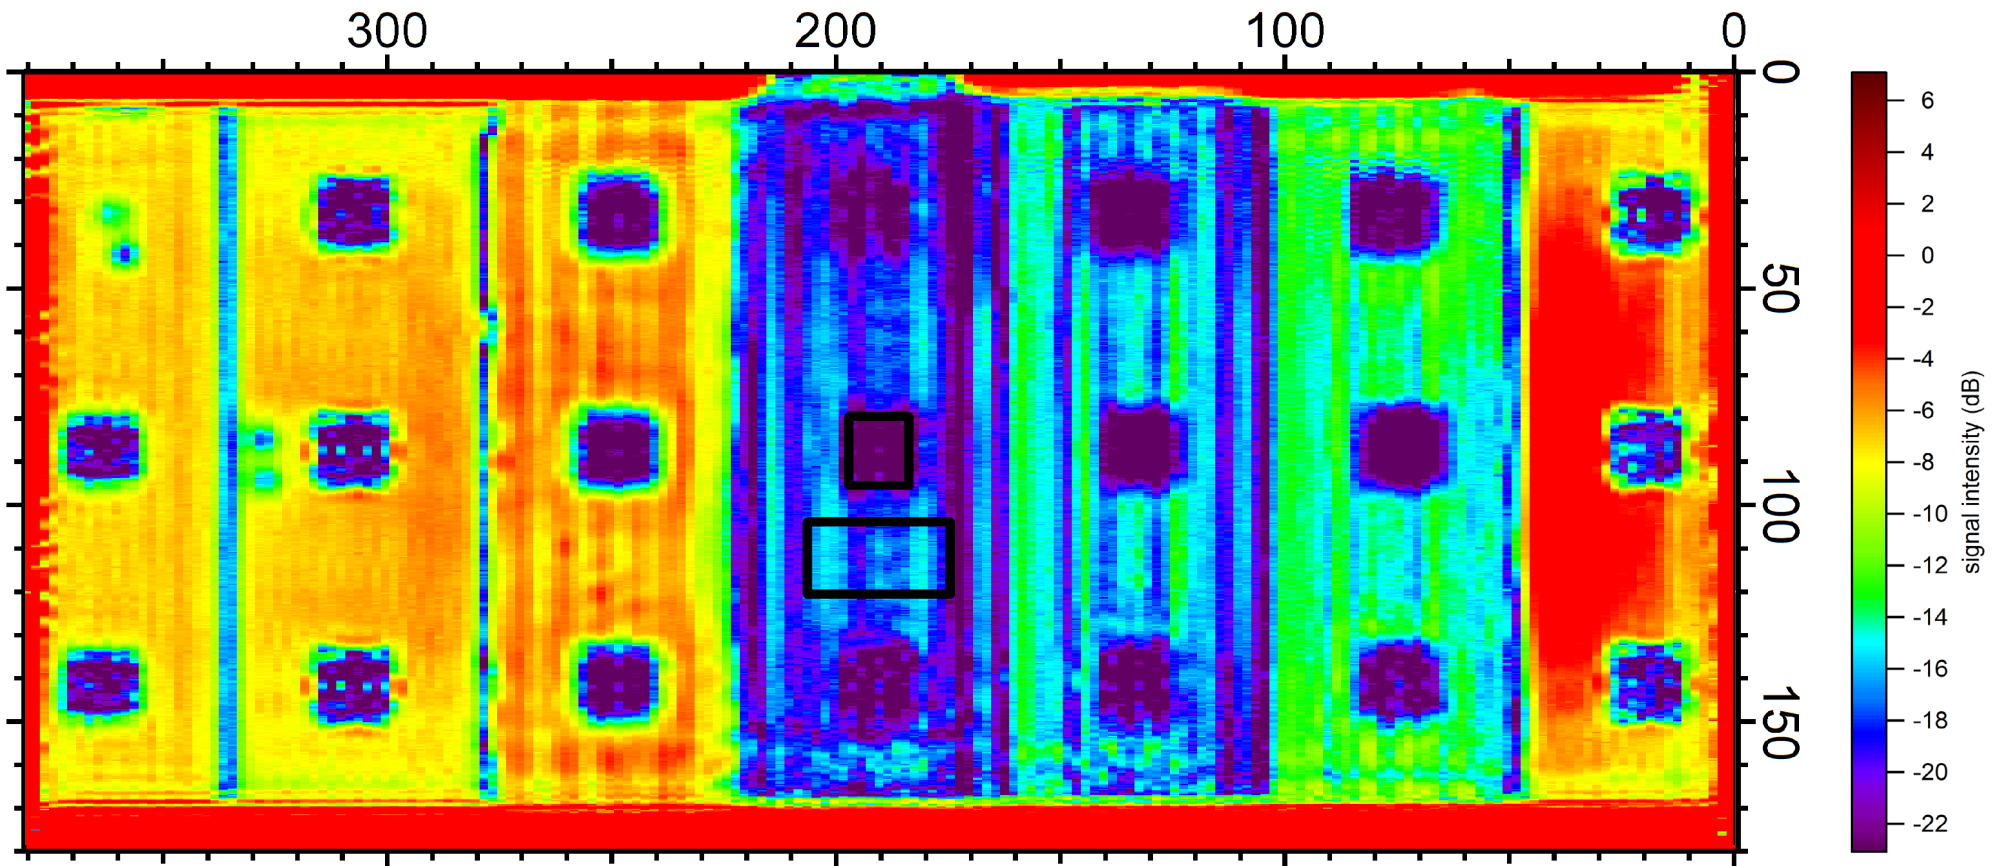
Full Scan with CF200 7E Transducer

▲ All Indications detectable

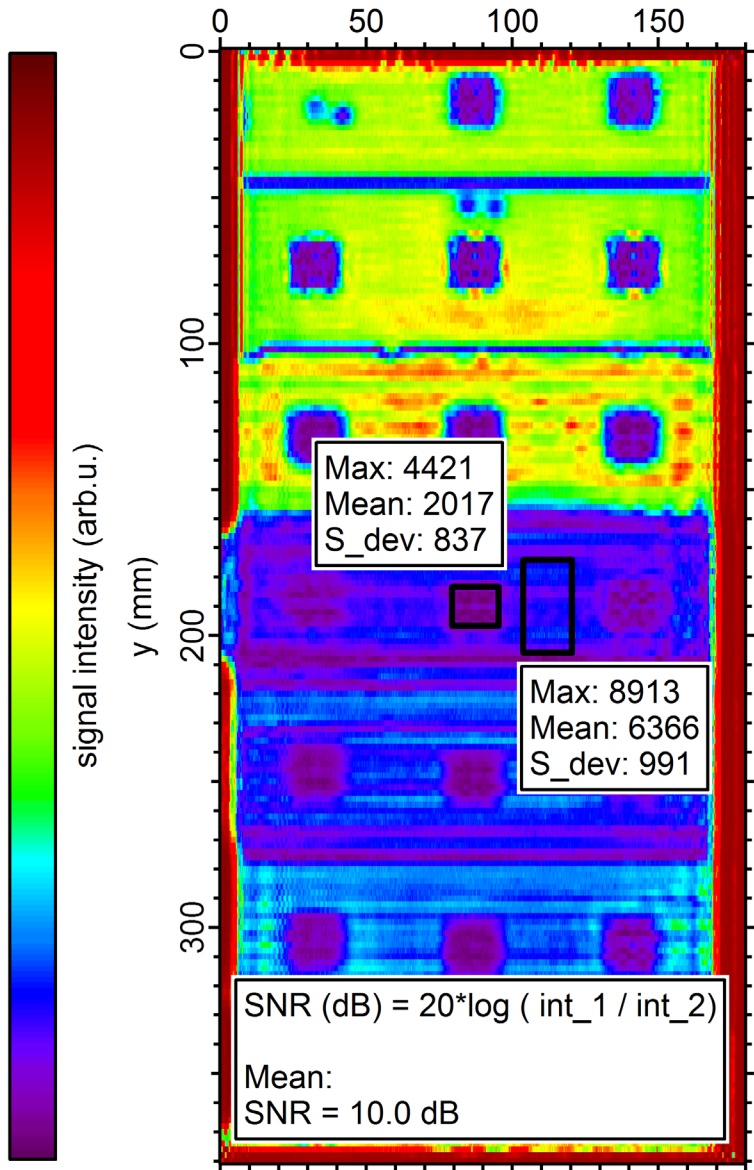
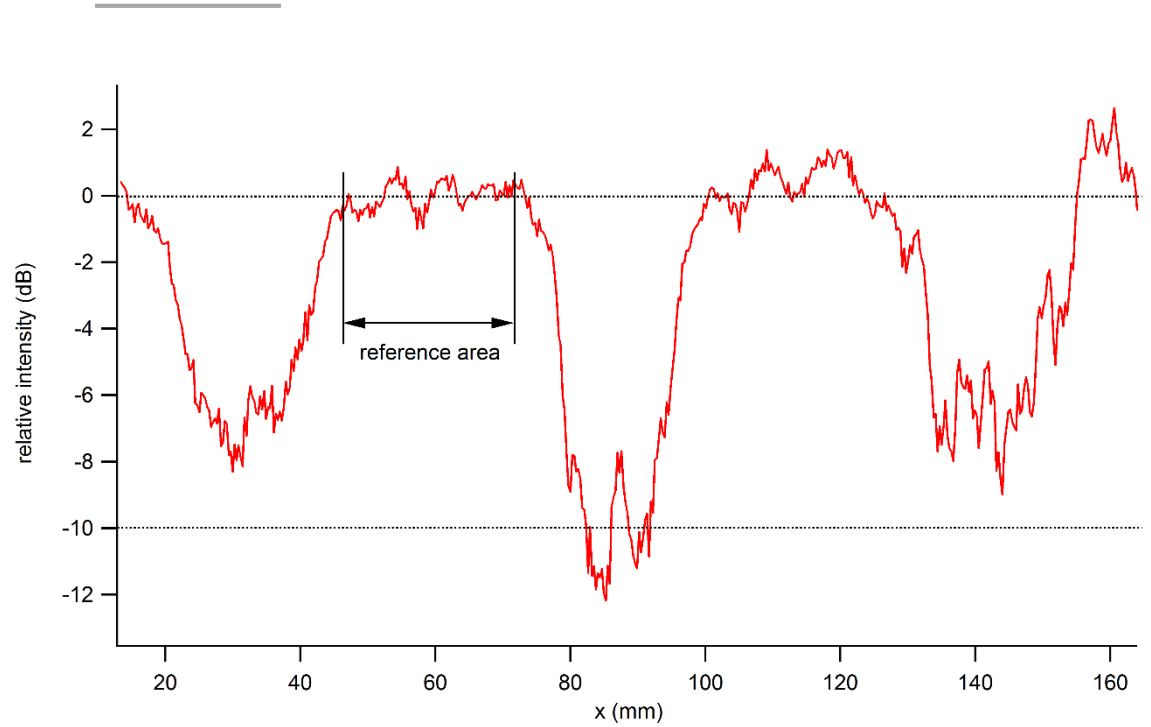
SNR Analysis

- ▶ ~10 dB SNR in region of interest
- ▶ Minimum of 6 dB SNR in the line profile
